Testing and Mitigation of a Complex Multifamily Building

Jeremy Ling, Precision Inspections and Radon Solutions

Bob Lewis, PA DEP, Radon Division

Lancaster Co. Retirement Community

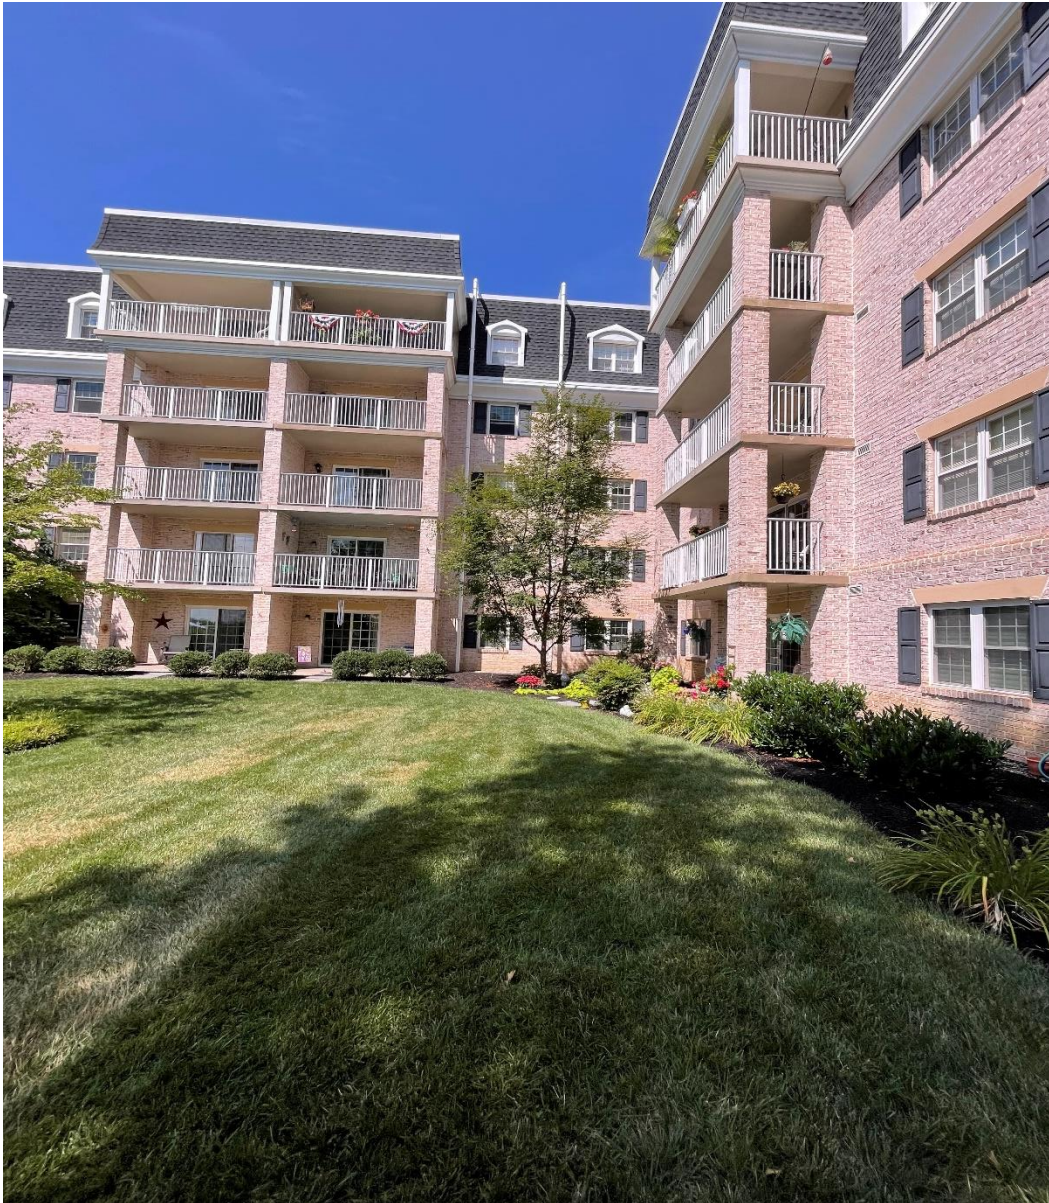
Dual Four-Story Pipe Run

Potential footer may have impeded PFE. Added two suction Pts. On either side.

Outside suction pts. can prohibit adding additional suction pts. To affected units.

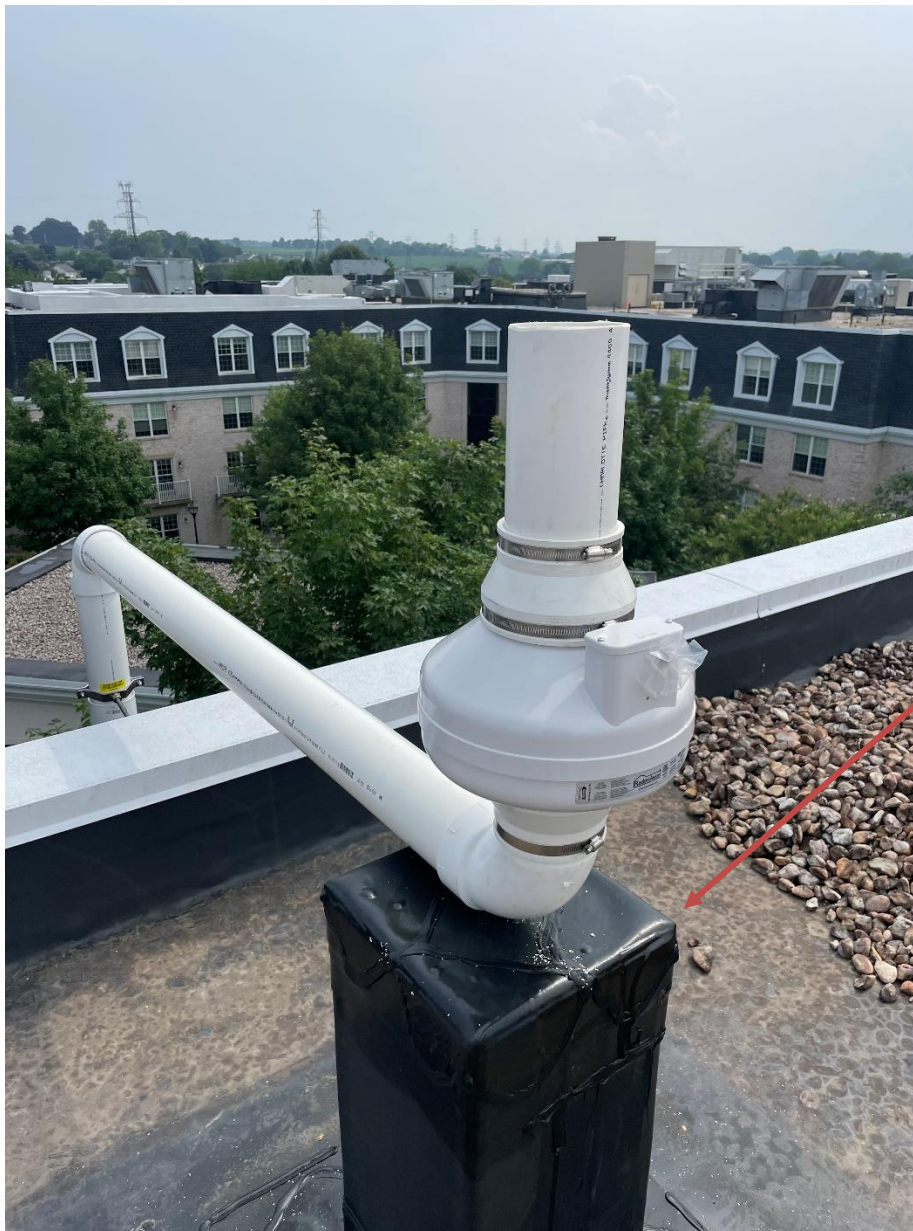
Fan Mount on Roof

Box for fan support
had to be installed by
roofer.

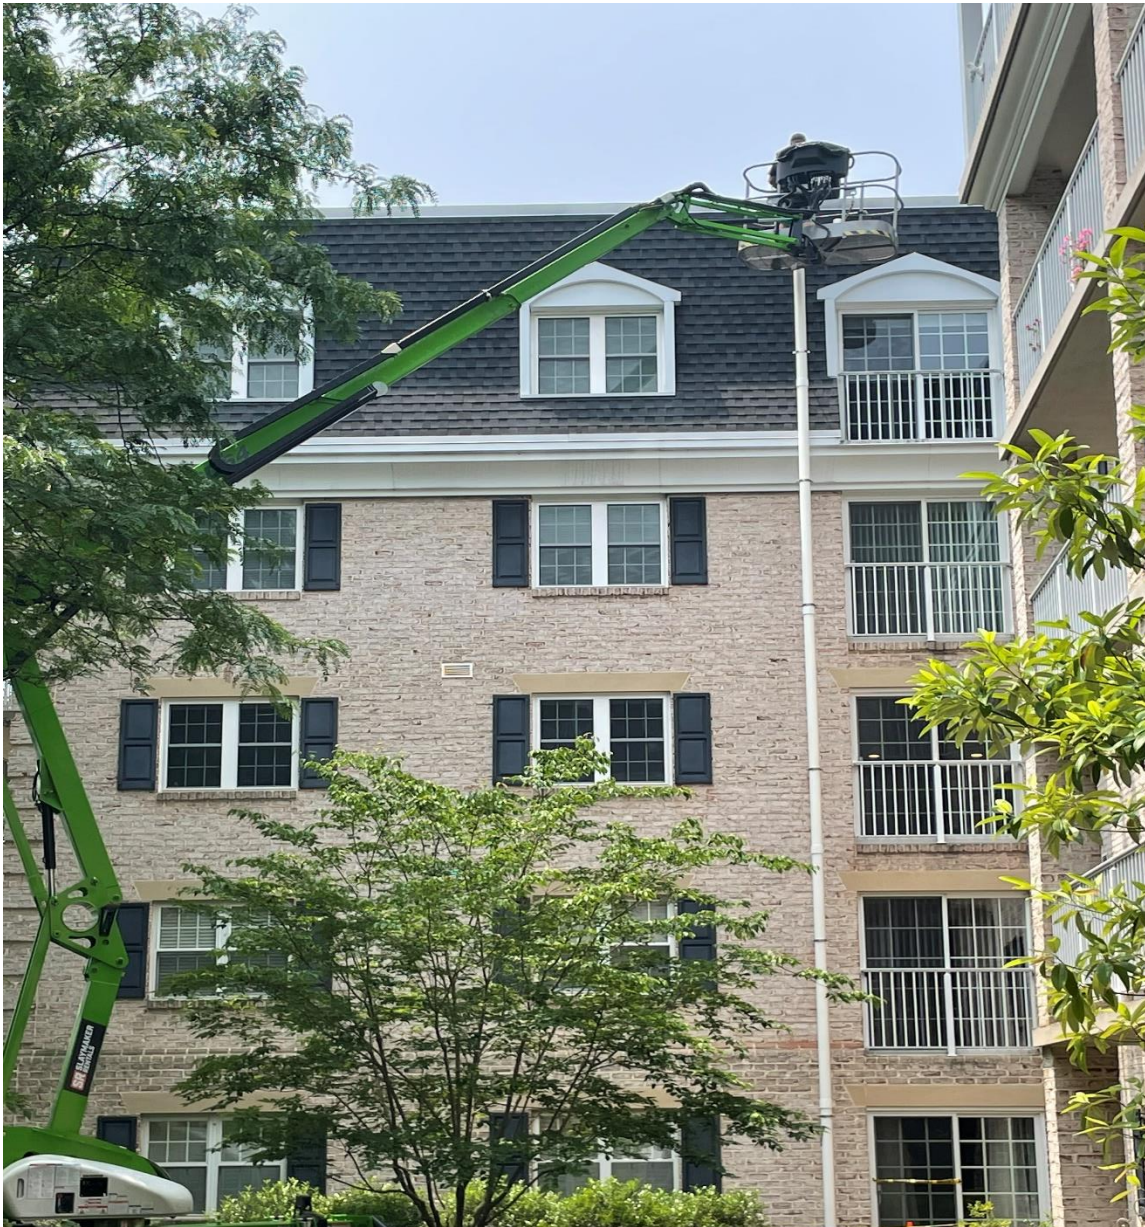
Five-story lift

Safety large concern, both for user and residents.

Bottom unit cordoned off for safety.

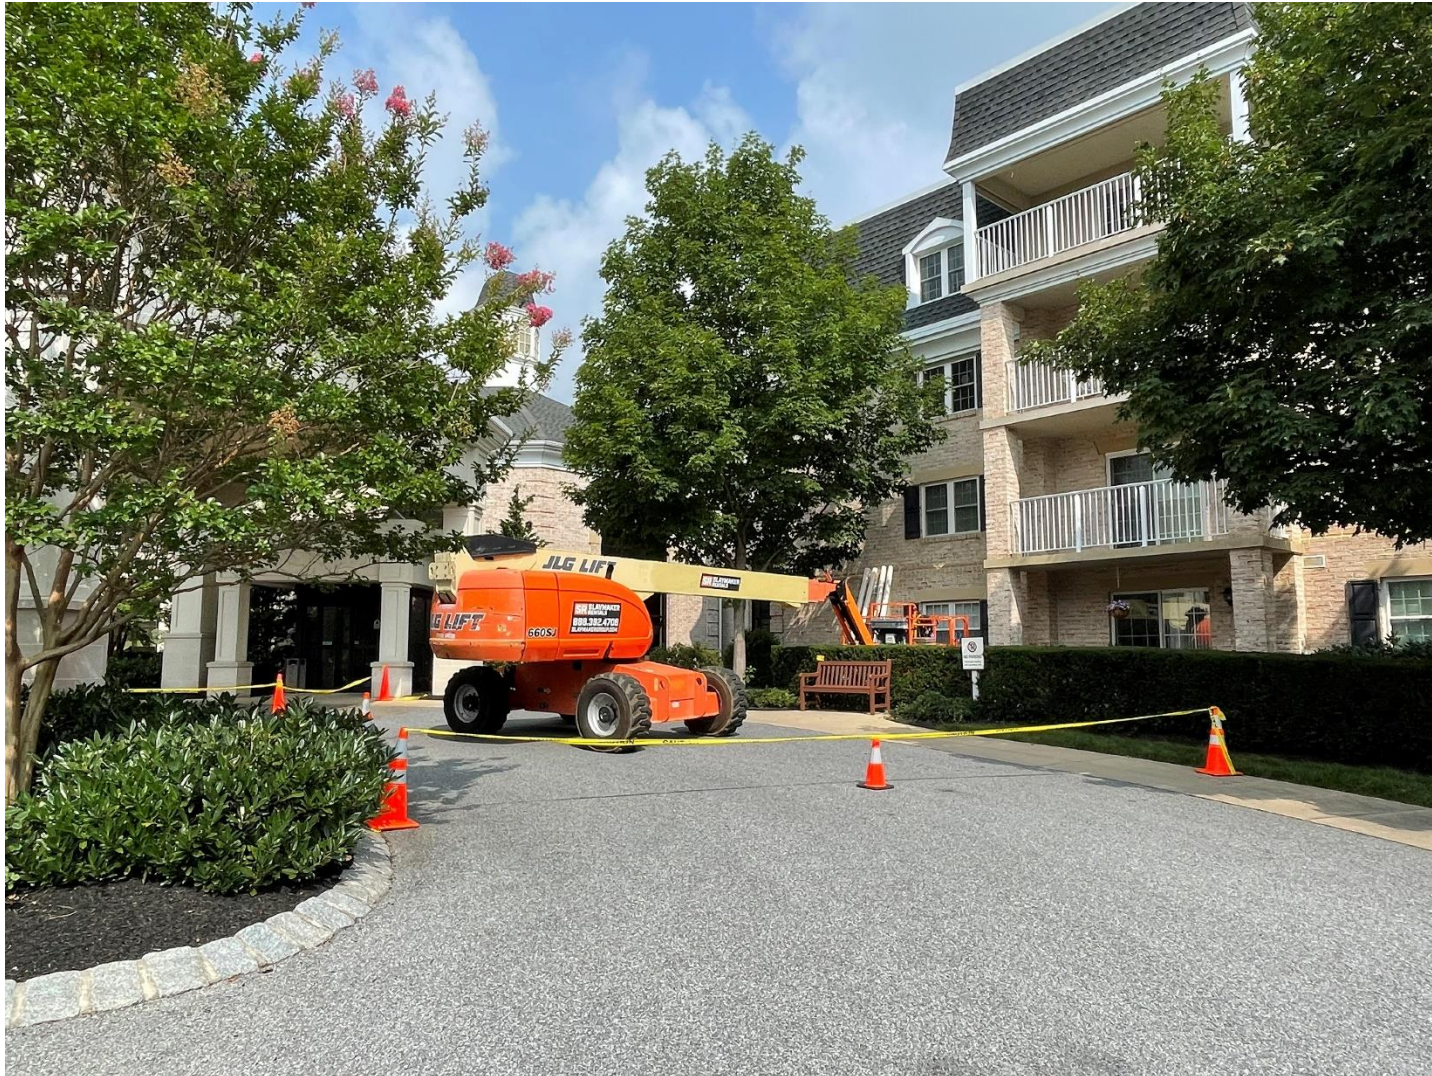
Lift Set-up.

Safety perimeter.

~\$2,000/wk.

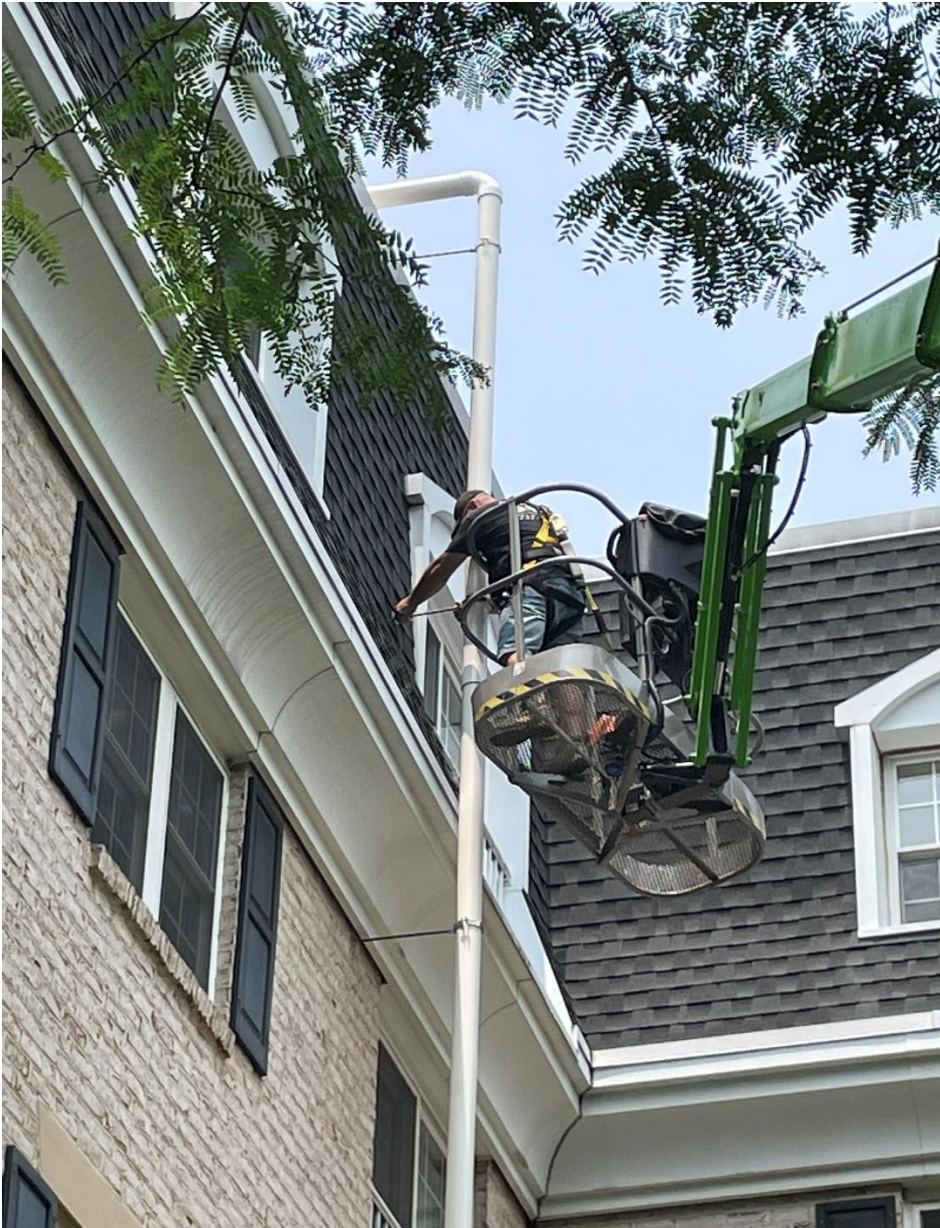
Pipe Mounting Brackets

Special stainless-steel brackets,
custom fabricated.

~\$85/ea. Seven bracket per
system.

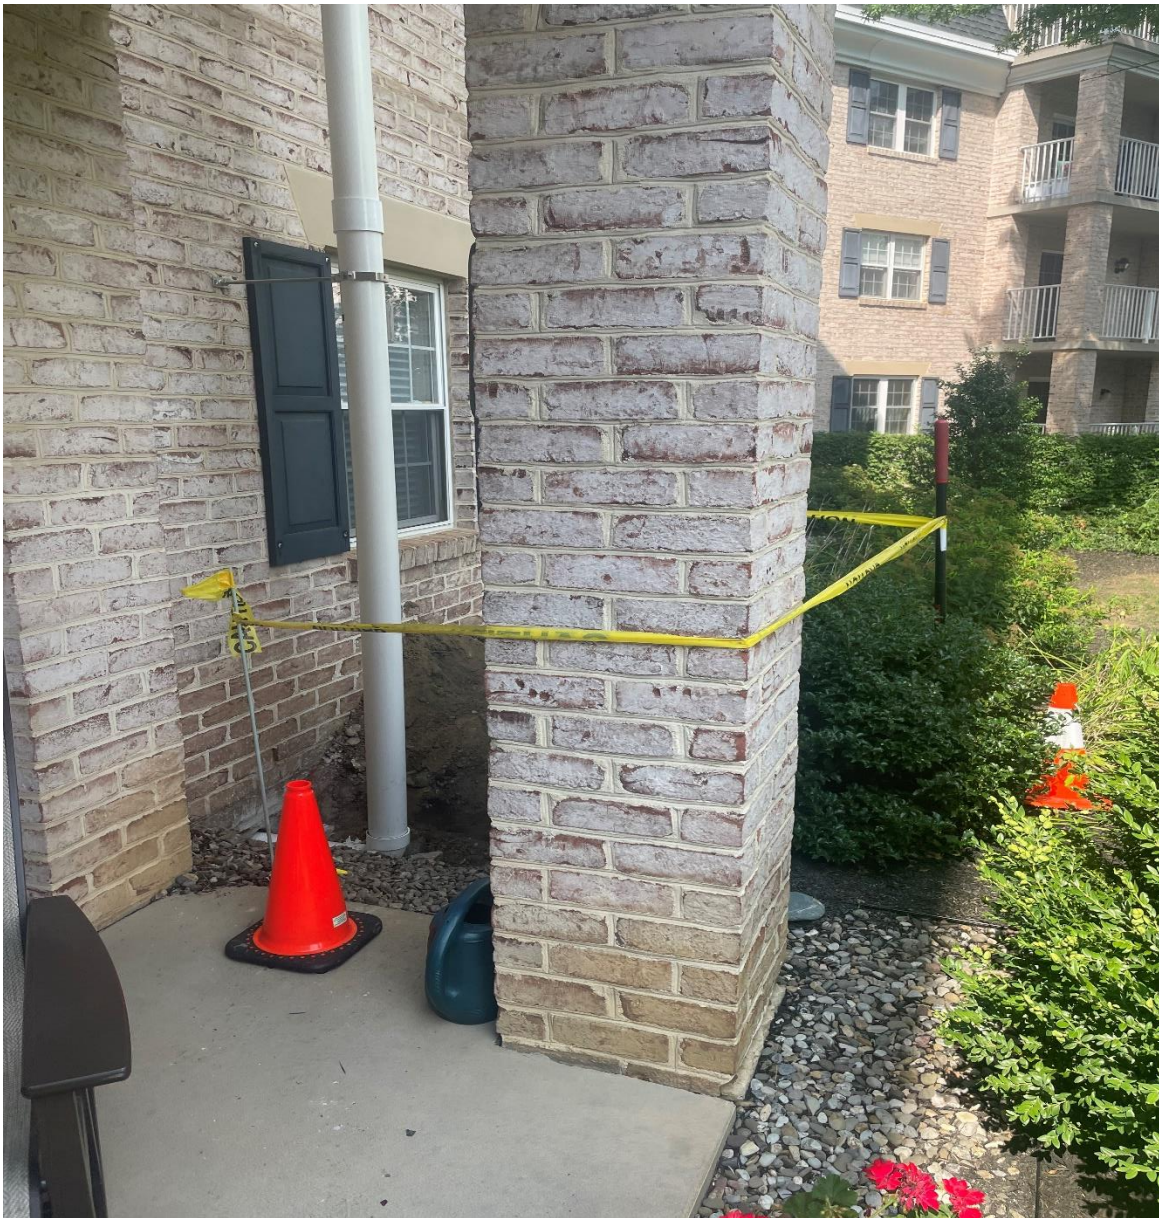
Through the Footer.

Used wet core drilling using 5" bit thru footer. Footer approx. 22" thick.

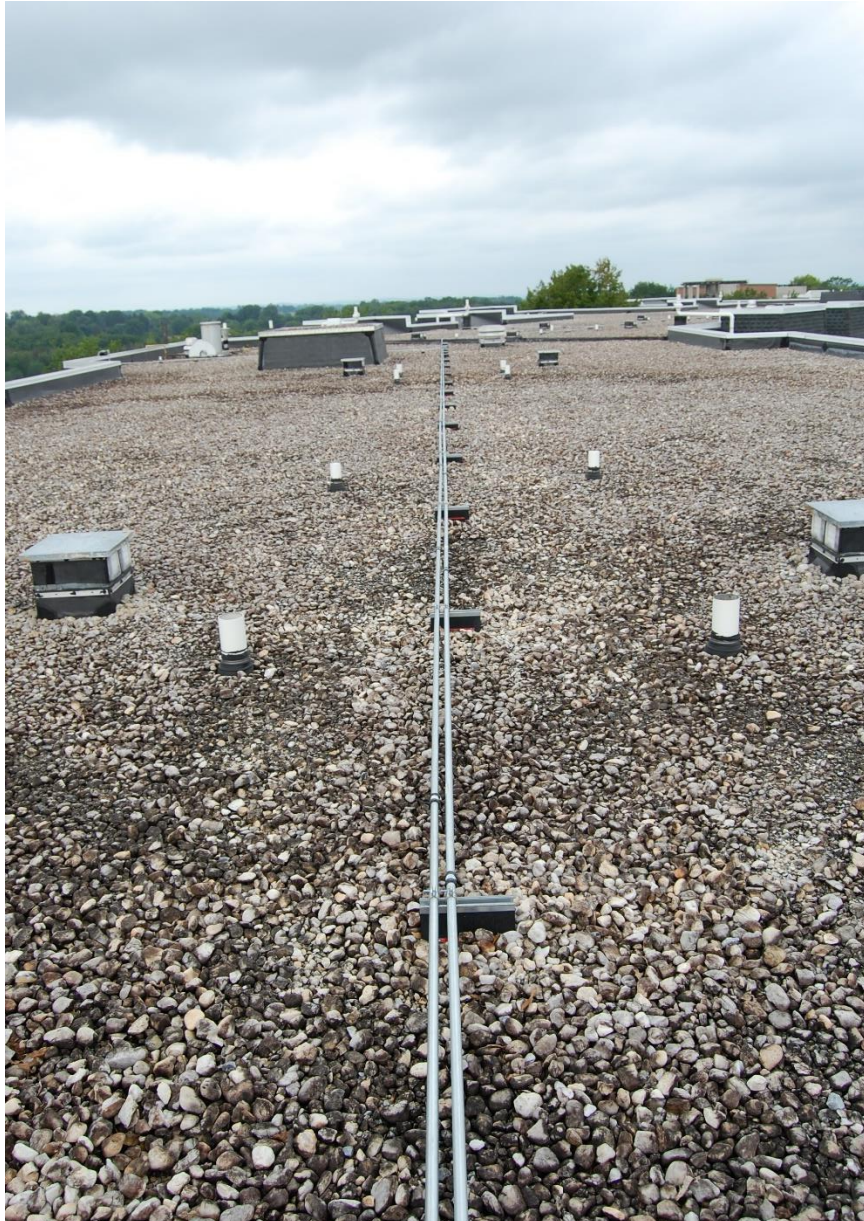
Electrical Run

Licensed electrician required, supplied by Retirement Complex.

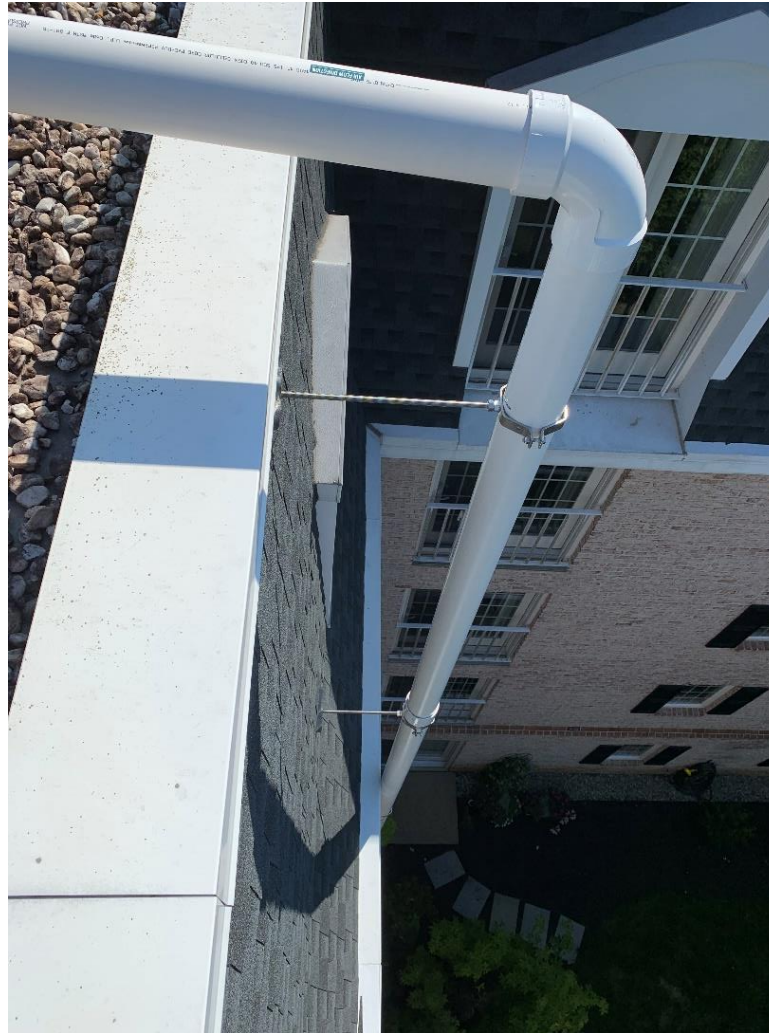
Pipe Run and Aluminum Bracket

Brackets at ~ 7 foot intervals.

All pvc Schedule 40 pipe used.

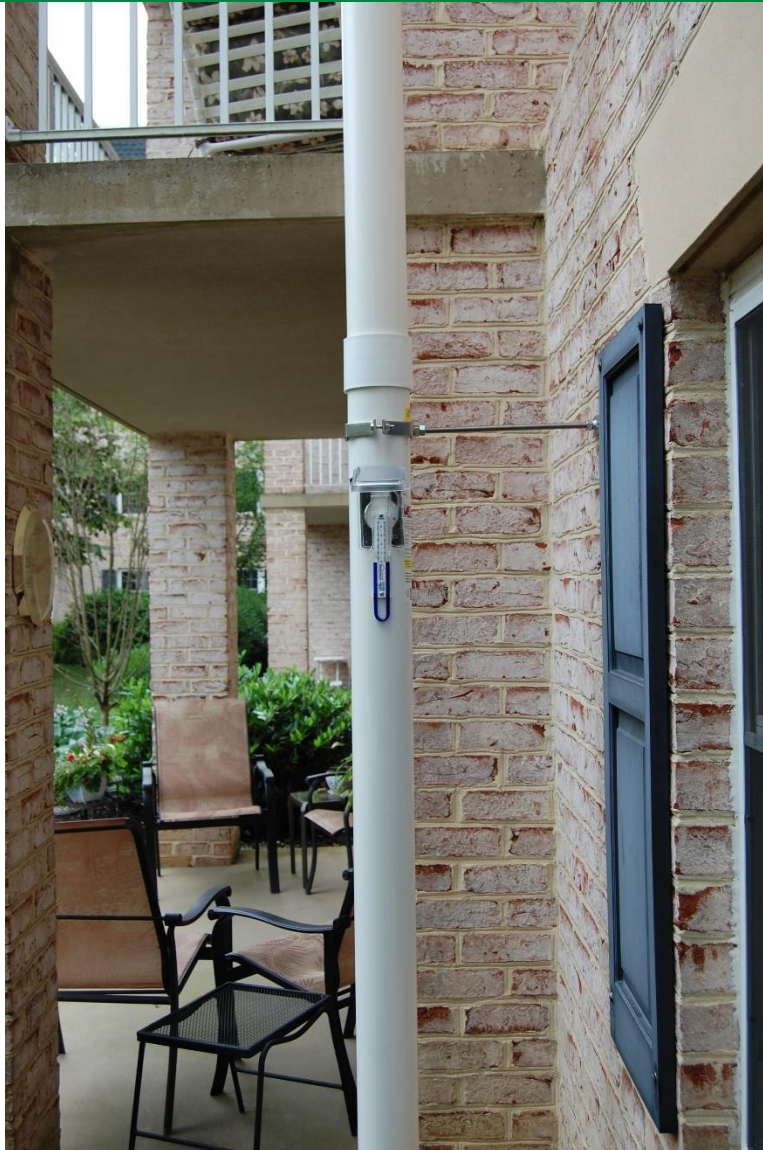
Waterproof U-tube

U-Tube Manometer in outside protective box.

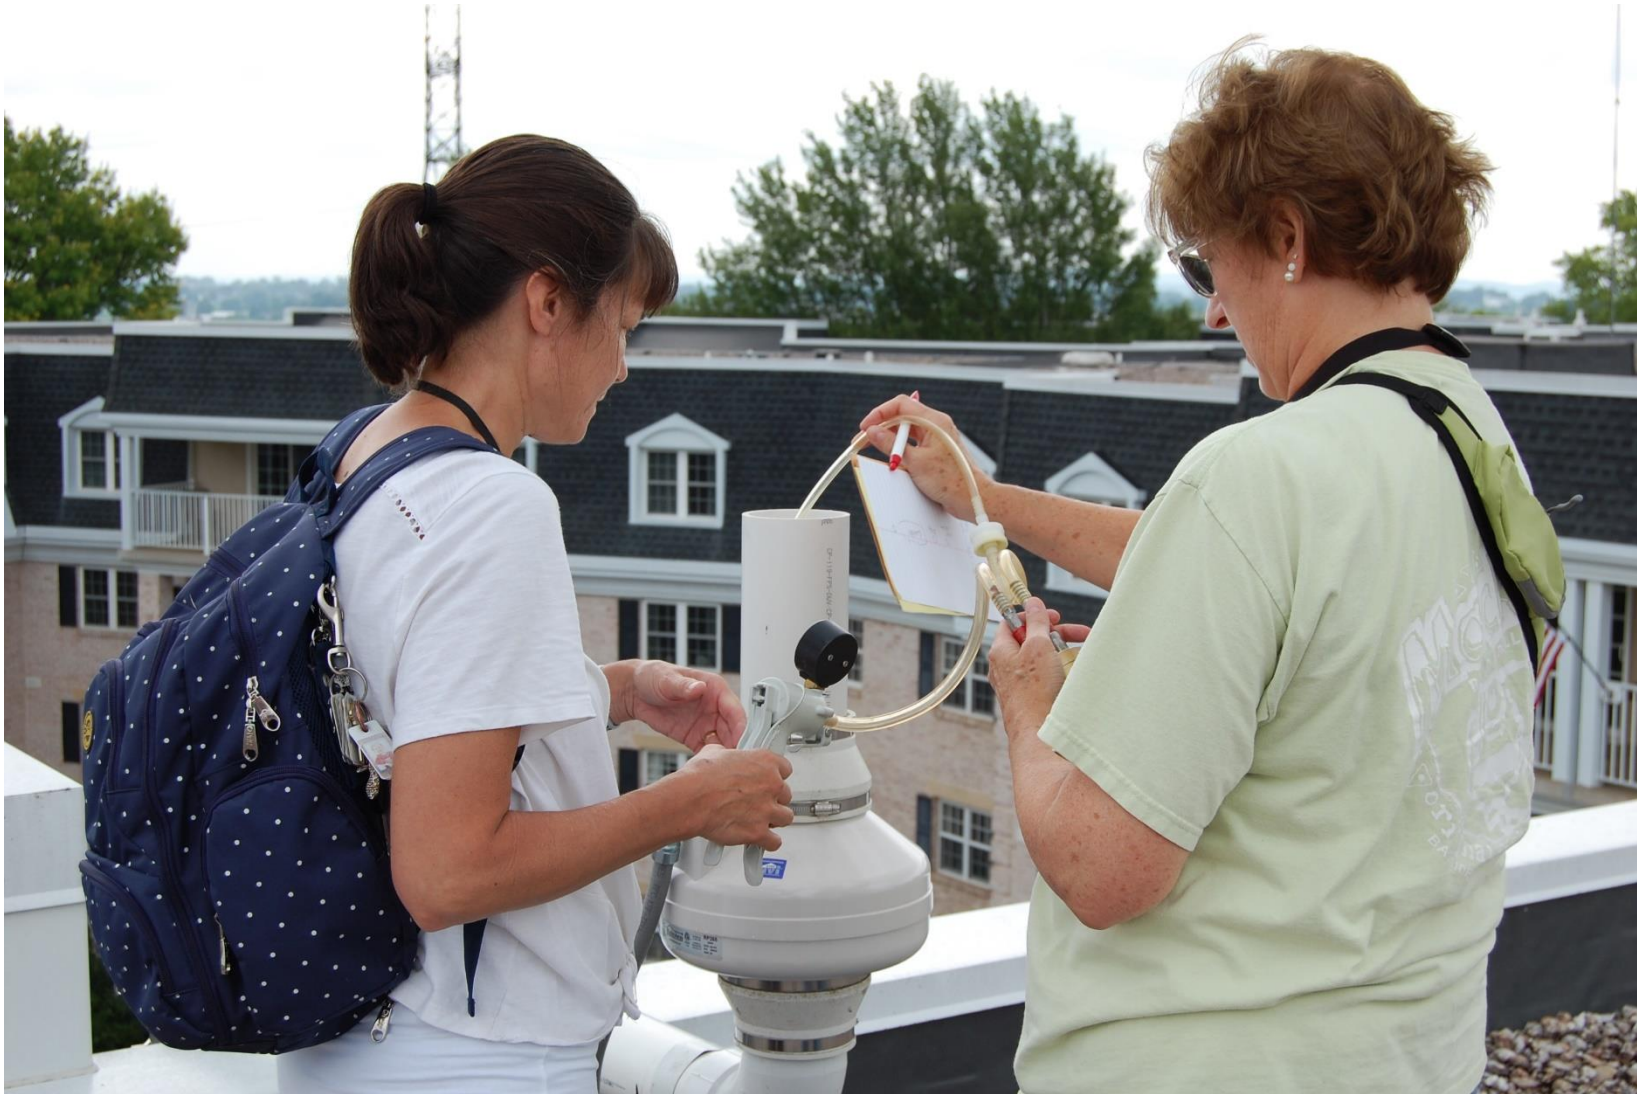
Exhaust Gas Sampling

Grab
sample
of roof
top
exhaust
.
