#### John Mallon

#### RADON DETECTION AND CONTROL ROUTE 51 WEST SOUTH HEIGHTS, PA

Homeowners Associations and Their Role in Radon Mitigation

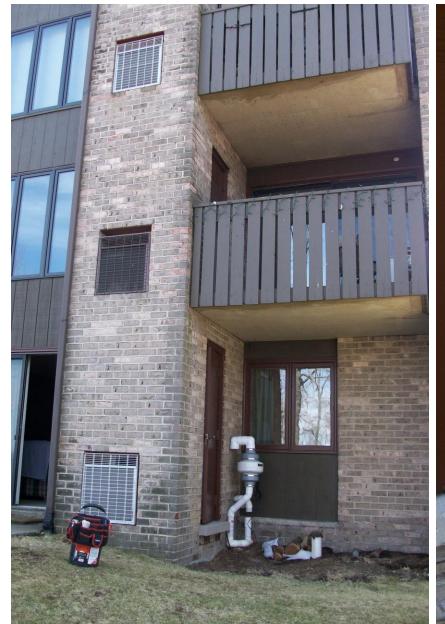
Beneath the bathtub and shower stall, there are open areas that go down to the ground.

The Active Soil
Depressurization System was
pulling air from this space
instead of from the sub-slab
soil air.

We filled it with self-leveling mortar mix using over three pours. Afterward, the readings decreased to an acceptable level.

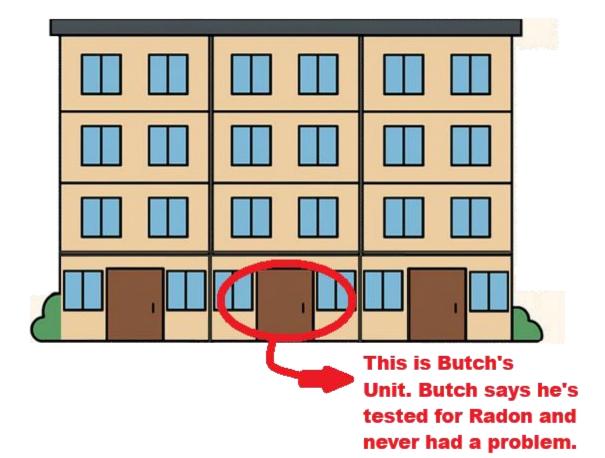
Upon inspection we determine that the ground directly below belongs to Butch\*

\* (This is not clear from the Sketch)

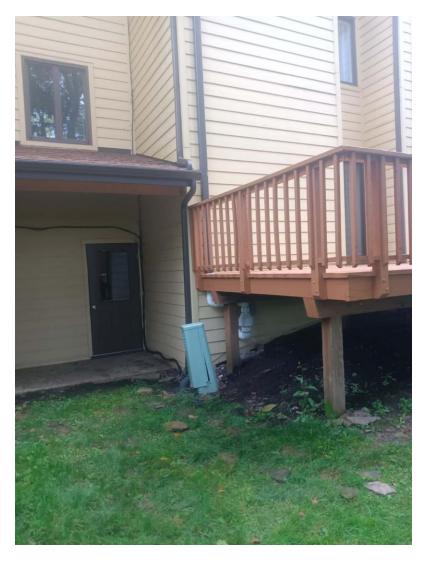
Actual Installation of fan at Butch's

Butch agrees to let Frank have RDCLLC put a Subslab suction point under his unit. Frank pleads with us to install it. We do!

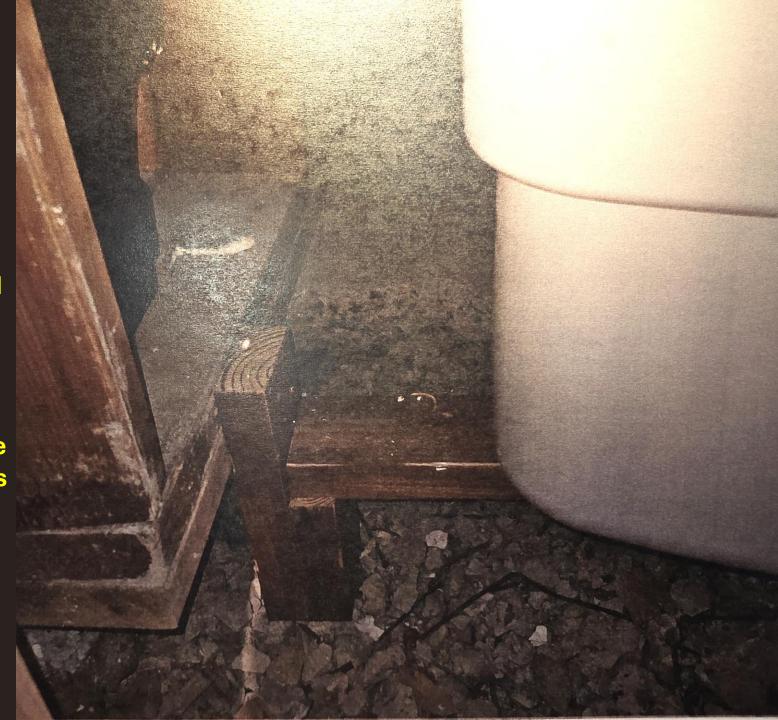
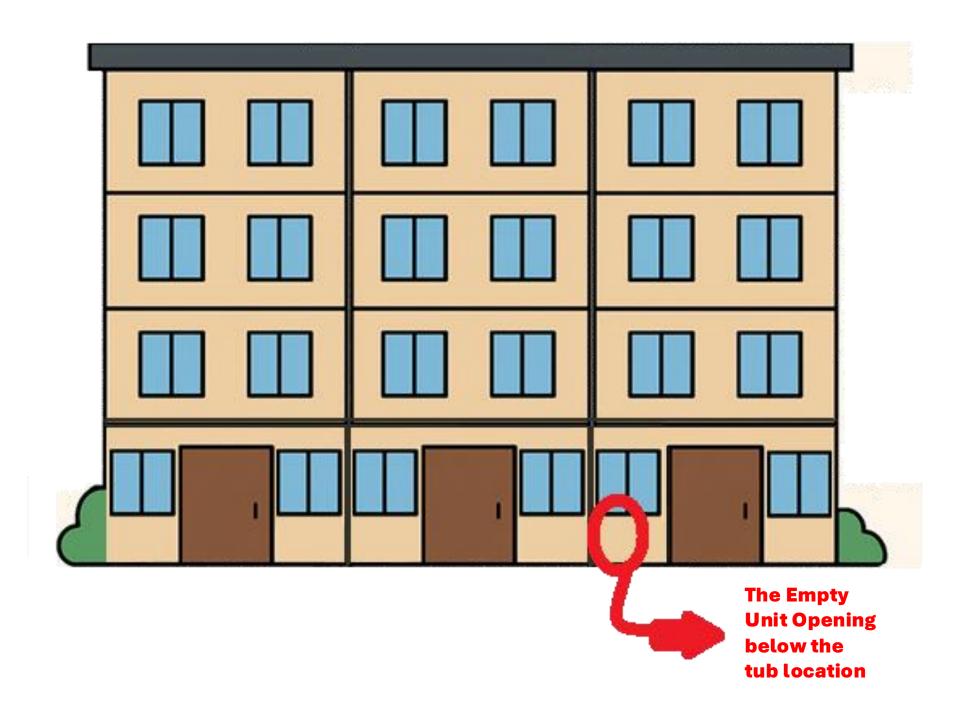
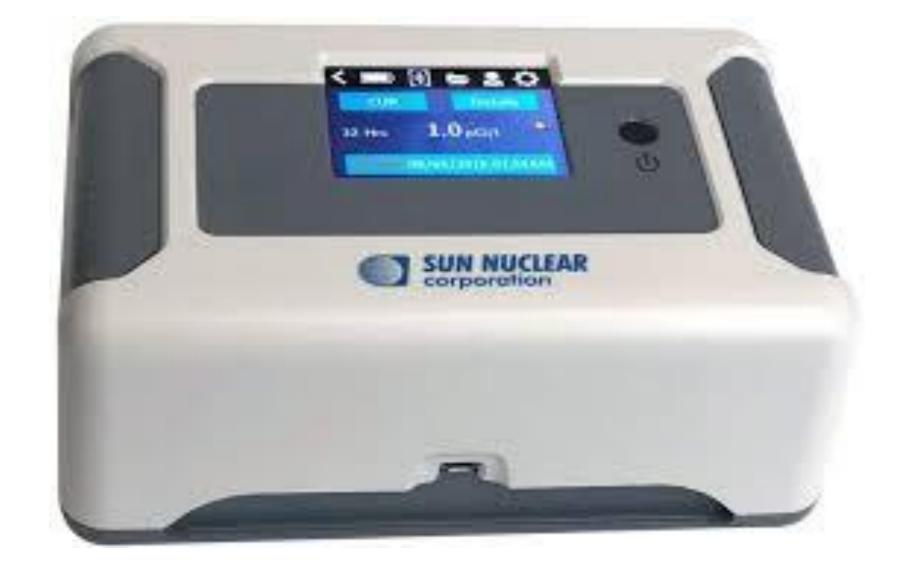
Eventually, they identified a probable issue in the *adjacent unit*, which was unoccupied. With access granted by the HOA President, a plumber's camera was used to inspect the area, revealing a large hole beneath the bathtub slab. To reach the site, a hole was cut in Butch's drywall and floor. The slab opening was then filled using four bags of flowable cement delivered through a large pipe.

Levels dropped to less than 4pCi/L.
